Manhole Inspection Summary

Manhole # S23C1_020MH

Location Address: **2444 Maisel Ct**

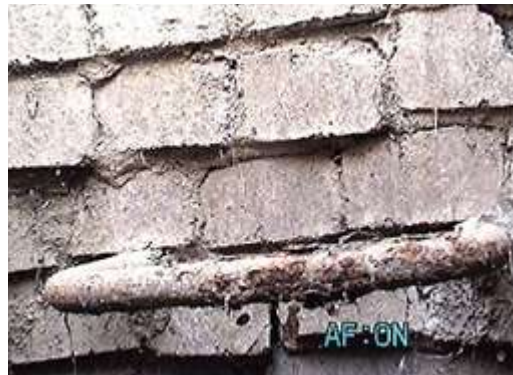
Defect 1

☒ **Corroded**

corroded Step

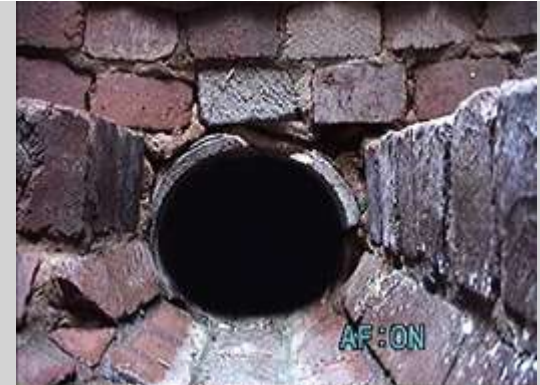
12 O'Clock Outflow

8 in. Circular Gravity Sewer
Pipe Out @ 12 O'Clock

Pipe Height: **8.4** (in.) Rod and Bar (Angled)
Pipe Material: **Clay** ☐ Pipe Lined
Invert Depth: **5.83** (ft.) Flow Characteristics: **Slow**
Deposits: ☒ None ☐ Mud ☐ Sludge ☐ Debris ☐ Grease
Silt Depth: **0** (in.) Deposits Extent:
Infiltration: **None** Pipe Seal Cond: **Broken**

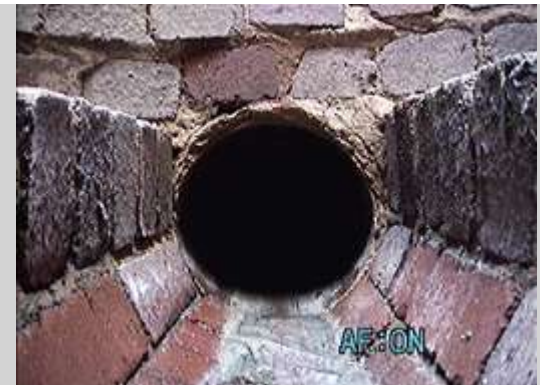
6 O'Clock Inflow

8 in. Circular Gravity Sewer
Pipe In @ 6 O'Clock

Pipe Height: **8.4** (in.) Rod and Bar (Angled)
Pipe Material: **Clay** ☐ Pipe Lined
Invert Depth: **5.69** (ft.) Flow Characteristics: **Slow**
Deposits: ☒ None ☐ Mud ☐ Sludge ☐ Debris ☐ Grease
Silt Depth: **0** (in.) Deposits Extent:
Infiltration: **None** Pipe Seal Cond: **Sound**

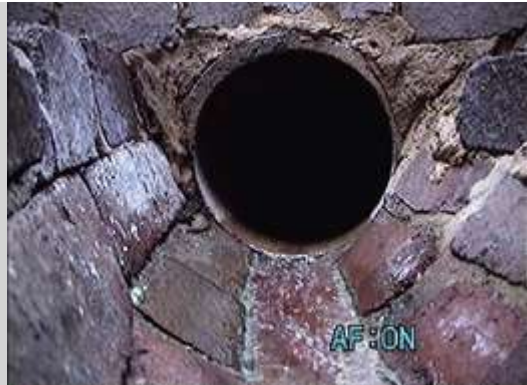
9 O'Clock Inflow

6 in. Circular Gravity Sewer

Pipe In @ 9 O'Clock

Pipe Seal Cond: **Sound**
